International Journal of Architectural Heritage

Traditional Turkish Masonry Monumental Structures and their Earthquake Response

Online Publication Date: 01 July 2007

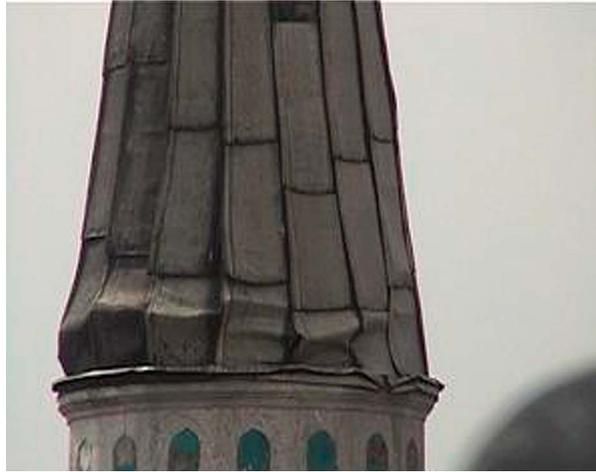
In masonry minarets, the spire is either constructed monolithically with the rest of the minaret using the same masonry units or constructed as a wood frame covered by metal, typically lead plates. In cases in which the structural systems of the minaret body and spire are different, the stiffness and strength and the resulting structural response appear to be different for the two components. Especially when the spire is not anchored properly to the minaret body, spire damage similar to that shown in Figure 8 is observed after the earthquakes. Proper anchorage of spire may limit the damage to spire and prevent it from falling down. As listed in Table 1, a couple of minarets had damage to their spires in Istanbul during the 1999 earthquakes.

Figure 8. Photograph of damage to minaret spire after the 1999 earthquakes (SDR 2005).

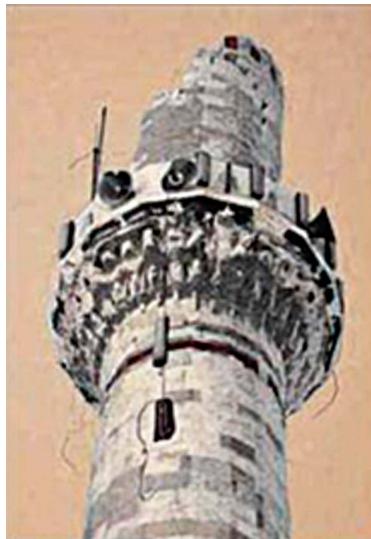
Damage to the upper portion of the minaret body is observed less frequently. One reason for this is the bending moment demand imposed by the lateral loads, either by wind or earthquakes, is relatively small compared to the lower parts of the minaret. Figure 9 shows one rare example of minaret sustained damage above the balcony level. The inclined failure surface is an indication of shear failure rather than a flexure or bending moment failure; however, the shear forces should be relatively low compared to the bending moments at that elevation.

Figure 9. Photograph of damage to a minaret above of its balcony level (CIAI'S 2006).

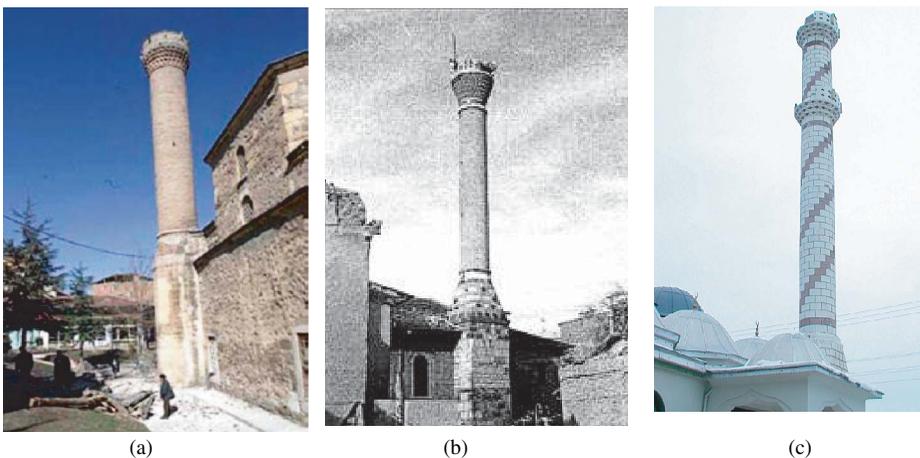
The location, size, and decoration of balconies are important for architectural reasons; however, they typically create structural irregularities over the height of masonry minarets. This irregularity is mainly because the uniform size of the minaret body increases at the balcony level by addition of tapered cantilevers around the perimeter. The detailing and construction of cantilevered masonry balconies are usually very difficult and require high-quality workmanship. The tapered bottom face of the balcony and the balcony itself are normally used for decoration purposes. Even though a moderately gradual diameter increase is provided just below the balcony, the local structural behavior highly depends on the details of the connections between the masonry units in that region. Usually because of poor detailing, the minarets tend to fail around the balcony level as shown in Figure 10. The other common reason for failure at the balcony level is the existence of a door (a rectangular opening) in the minaret body, which abruptly reduces the shear and flexural strength of the minaret significantly.

Figure 10. Photographs of damage at the balcony level during recent earthquakes: (a) February 3, 2002 Sultandagi earthquake (KOERI 2002), (b) February 3, 2002 Sultandagi earthquake (Utku et al., 2003), and (c) November 12, 1999 Duzce earthquake.

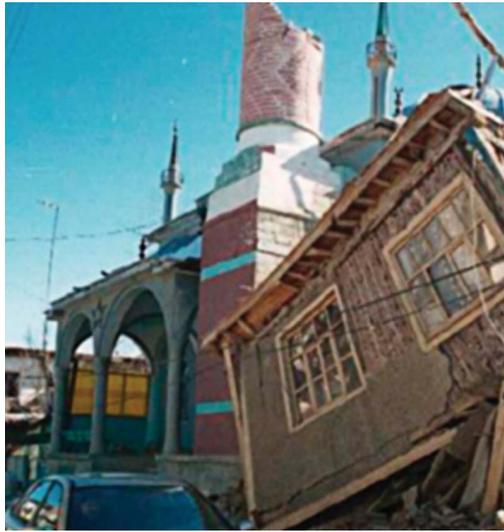
Failures within the cylindrical minaret body were occasionally observed between the transition region and balcony. Figure 11 shows one such failure in a brick masonry minaret after the 2002 Sultandagi earthquake. Inclined failure surface suggests that the collapse was most likely due to shear rather than the bending effects. Figure 12 shows another similar example where the square boot of the collapsed minaret was constructed separately but very close to the mosque walls. It is possible that the observed damage was caused by the impact between the minaret and mosque structure.

Figure 11. Photograph of damage from failure within the cylindrical minaret body (KOERI 2002).

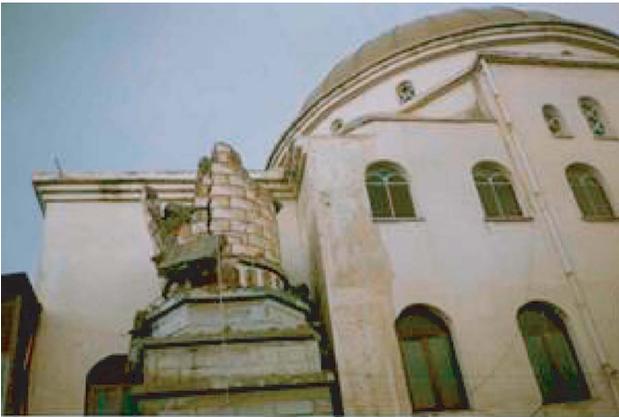
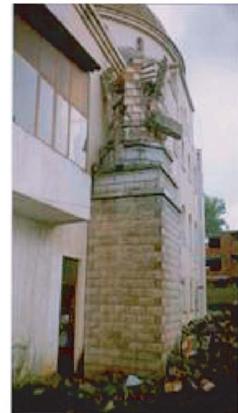
Figure 12. Photographs of damage from failure due to crushing at minaret of Emir Bayır mosque (Firat 1999).

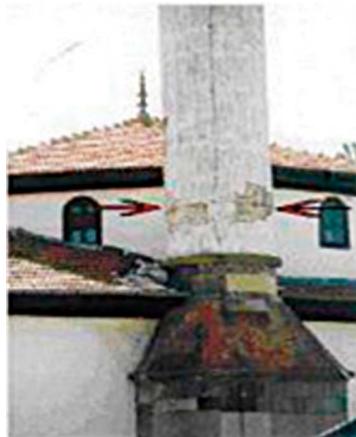
Figure 13. Photograph of damage from cracking and damage in the minaret of the Cambazzade Ahmet mosque in Orta, Cankiri (Kasapoğlu et al., 2000).

observed damage, including cracks concentrated on each side of the minaret, is an indication of large bending stresses rather than shear effects. It appears that this more than 200-year-old minaret, if not strengthened, will probably collapse during a potential future stronger earthquake. Cankiri is within a close distance to the very active North Anatolian fault, which has produced and is likely to produce much stronger earthquakes in the near future.

The type of damage seen in Figure 13 usually occurs in slender and taller minarets where the bending demands can easily surpass shear demands near the bottom of the minaret body. In shorter masonry minarets, in addition to large bending moments, the shear forces can be relatively large with resulting failures similar to those shown in Figure 14. The historical minarets shown in Figure 14 collapsed during the earthquakes in August 17 and November 12, 1999. The Imaret mosque is one of the oldest structures in the region, and its minaret was built using combination of stone blocks and small bricks bounded by a thick layer of mortar (Figure 14a). Similar

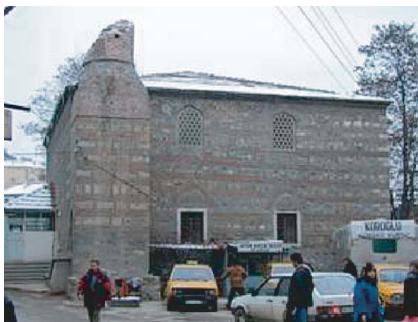
(a) 600 year old Imaret mosque in Bolu

Figure 14. Photographs of damage from failures near the bottom of the polygonal and cylindrical minaret body.

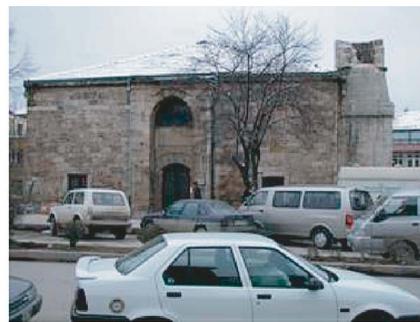
(b) 500 year old Kadi mosque in Bolu

damage along an inclined failure plane occurred in the Kadi mosque minaret (Figure 14b), which was constructed using stone blocks reinforced with iron clamps as illustrated in Figure 5.

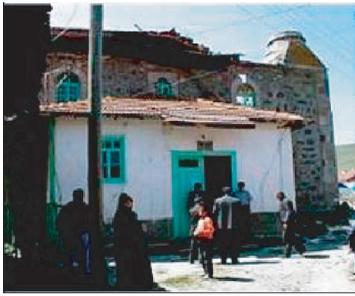
(a) Collapsed minaret during the June 6, 2000 Çankırı-Orta ($M_s=6.1$)

Figure 15. Photograph of damage from collapsed masonry minarets in recent earthquakes: (a) Taşkın et al., 2003, (b) Wenk et al., 1998, (c) Ulusay et al., 2002, and (d) Doğangün 2004.

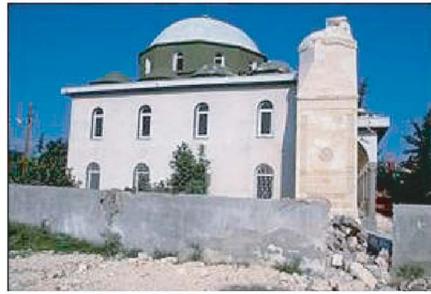
(b) Collapsed minaret during the June 27, 1998 Adana-Ceyhan earthquake ($M_s=5.9$)

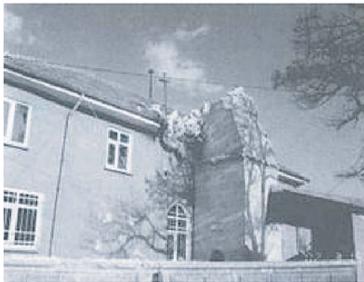
(c) Collapsed minaret during the February 3, 2002 Sultandağı earthquake ($M_w=6.5$)

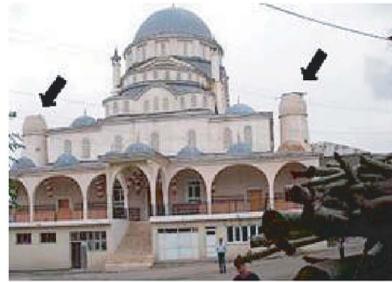
(d) Collapsed minaret during the May 1, 2002 Bingöl earthquake ($M_w=6.4$)
