## Traditional wooden buildings and their damages during earthquakes in Turkey

*Keywords:* Earthquake damages; Turkish traditional wooden buildings

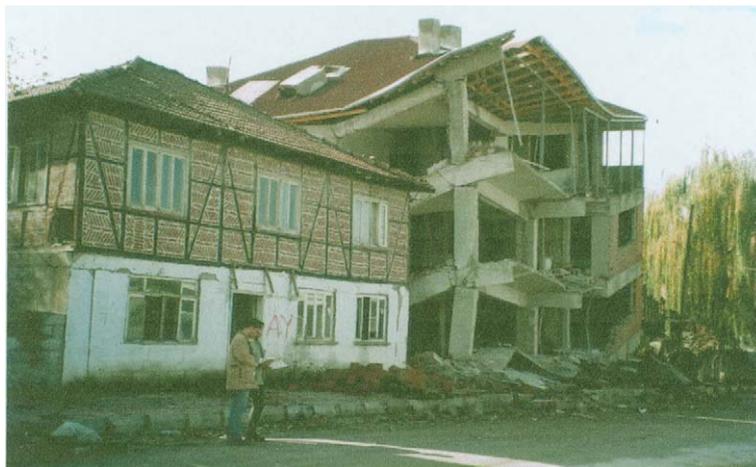
Fig. 1. View of traditional and reinforced concrete buildings after the 1999 Duzce earthquake.

Some traditional buildings were damaged due to collapse of neighbor modern reinforced concrete buildings (see Fig. 1). In at least three cases reinforced concrete structures hit or pounded against the timber frame buildings collapsing them during the 1999 Kocaeli earthquake.

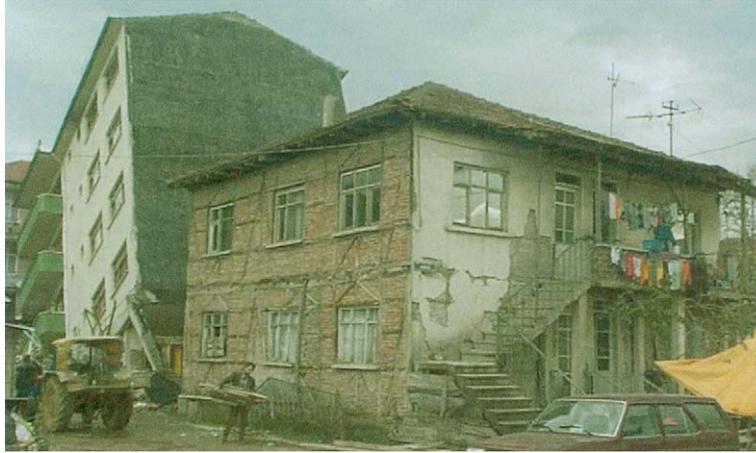
Fig. 2. A view for neighbor traditional and reinforced concrete buildings after the 1999 Duzce earthquake [7].

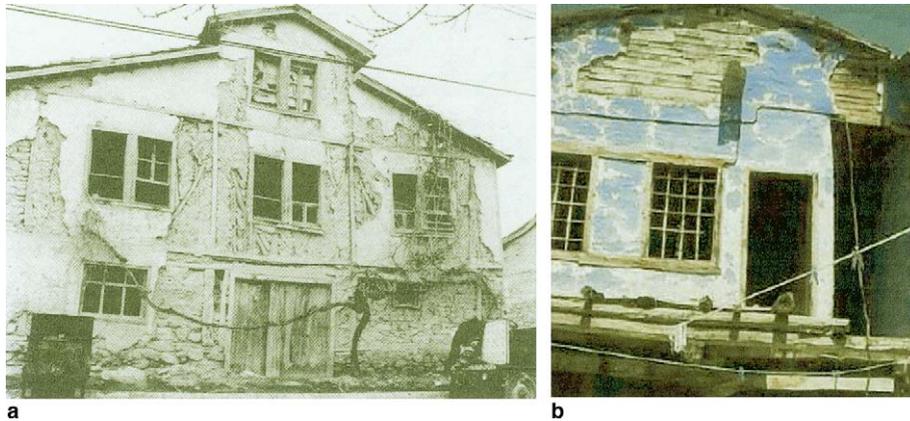
Its survival in the much larger and longer earthquake illustrates that the timber framed buildings is capable of maintaining stability over many cycles. To do this, however, the deflection of the structure and friction in the infill must begin at the onset of shaking. Thus, different from reinforced and masonry buildings, for timber framed buildings the shedding of the plaster and stucco in both the large and small earthquakes was similar. In other words the working of bracing elements in the earthquake dislodged the plaster as the oscillated building. The closely spaced studs reduced the likelihood of the propagation of cracks within masonry infill. The only visible manifestation of earthquake excitation was the presence of cracks in the interior plaster along the walls and at the corners of the rooms, revealing the pattern of the timbers imbedded in the masonry underneath. This level of damage was evident in every traditional timber framed buildings after a moderate or larger earthquake (Fig. 10). On the exterior, unless the masonry was covered with

Fig. 10. Views of cracked and fallen plasters during earthquake excitations. (a) A view of *himiş* construction after the 2002 Sultandağı earthquake [29]. (b) A view of *bağdadi* construction after the 2003 Buldan earthquake [15].

stucco, it is difficult to see damage with the naked eye. It should be noted that many walls were missing some of their infill, but evidence of ‘X’ cracks, so common in the infill in the modern reinforced concrete buildings [28], was non-existent in the traditional timber framed buildings.

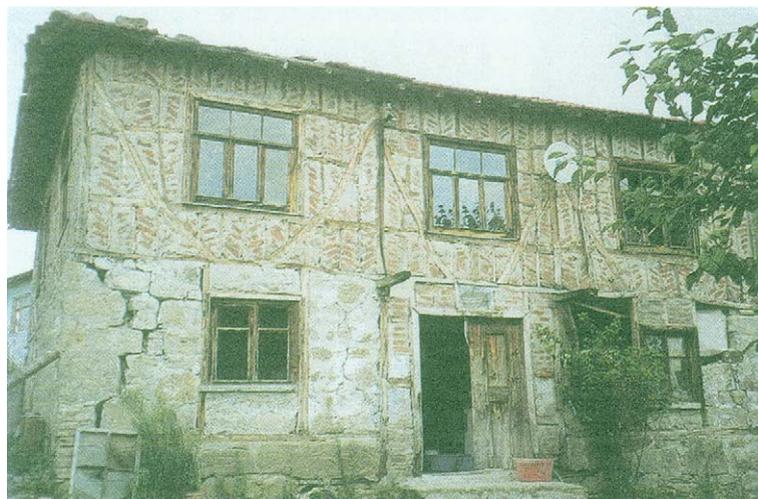
An important factor in the performance of the walls was the use of weak, rather than strong mortar. Fig. 11 shows failure of mortar in stone masonry infill during the 1999 Düzce earthquake. As a result of the different types of people constructing houses, it is not surprising to see that construction quality is variable. It is poor when; field rubble is used and bonded with mud mortar, without quoins and with no through stones etc. Especially during the moderate earthquakes (Doğubeyazıt, Erzurum, Pülümür and Çankırı Earthquakes), as given in Table 1, since the energy release was relatively small, none of or only

Fig. 11. View of failure of lime mortar during 1999 Düzce earthquake [30].

a few of reinforced concrete structures, slightly were damaged during these earthquakes. However, mud-stone masonry and Hatil constructions destroyed due to poor mud mortar and weak anchorage between mud and stone. The mud or weak lime mortar encouraged sliding along the bed joints instead of cracking through the masonry units when the masonry panels deformed. This served to dissipate energy and reduced the incompatibility between rigid masonry panels and the flexible timber frame.

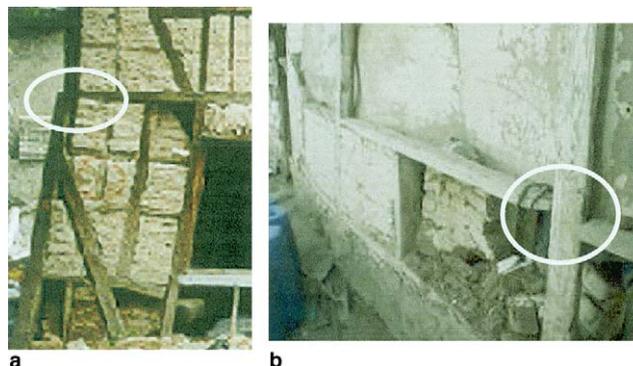
The connections of roof, floors, vertical framing elements and bracing elements make the building a single solid structure unit and are important features for holding a building together during earthquakes. Thus, the connections between the members must be strong enough to hold together without loosening or worse yet completely failing. It is extremely unlikely that a traditional timber framed building have not bracing element, could ever effectively resist lateral movements. As lateral earthquake effects are resisted by stiffness of connections, it would simply deform and collapse. Fig. 12 shows two connection failures during the 1999 Kocaeli earthquake and 2003 Buldan earthquake.

Fig. 12. Failure of connections in traditional timber buildings during earthquakes (a) Failure of connections during the 1999 Kocaeli earthquake [20]. (b) Failure of connections during the 2002 Buldan earthquake [15].

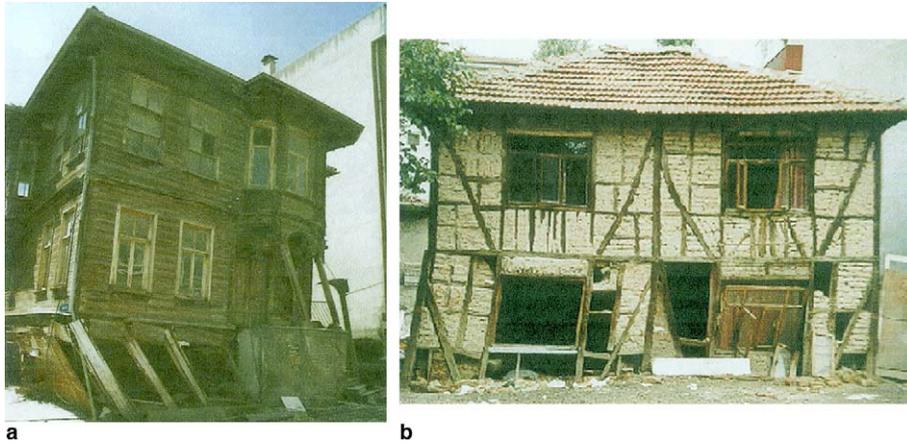
A large number of residential and commercial buildings built in Turkey had soft stories at the first-floor level on the two sides of main streets, because the first stories have been often used as stores and commercial areas [31]. These areas are generally enclosed with glass windows instead of brick infill walls so as to be used as showrooms. If first story of traditional timber building had more voids and fewer walls, it may behave as a soft story during an earthquake. The ground story of the buildings shown in Fig. 13 was heavily damaged,

Fig. 13. Heavily damaged traditional wooden buildings due to soft story. (a) Large laterally displaced traditional building [26]. (b) Laterally displaced traditional building [20].

but damage on the upper stories was limited and even the glass windows were unbroken. As seen from Fig. 13(b) a traditional building displaced laterally due to soft story although it has bracing element. As its bracing elements were not satisfied to resist lateral loads, still they prevented totally collapse.

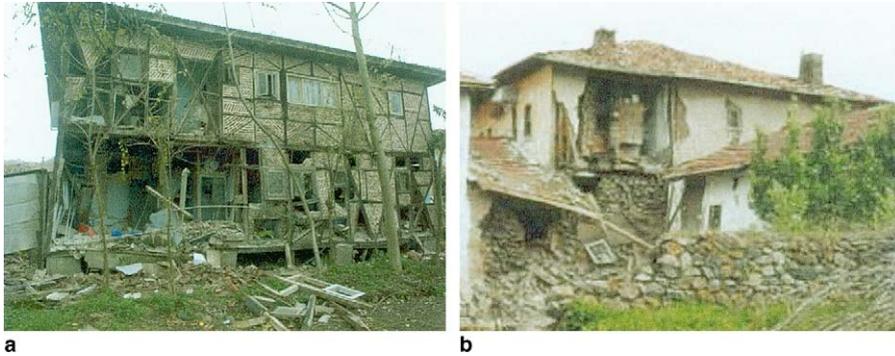
In many ways, the masonry infill dominated the performance of the frame, stiffening and strengthening it. It was evident that the infill masonry walls responded to the stress of the earthquake by “working” along the joints between the infilling and the timber frame; that is, the straining and sliding of the masonry and timbers dissipated a significant amount of the energy of the earthquake. In addition, by dissipating energy, the “working” also affects the natural vibration frequency of the structure.

Resonance with earthquake vibrations is a principal factor in the cause of earthquake damage to buildings in general. The controlled sliding and cracking of the infill masonry reduces the infill-frame structure’s ability to resonate with the earthquake by providing damping, just as a shock absorber does for a car [23]. The typical *hımış* construction does not have mechanical ties between the timber and masonry to hold the infill masonry in place. As a result, in some cases, small sections of the infill were shaken out from between the studs near the top of the upper-story walls. Because of the existence of the timber studs, which subdivided the infill walls into small panels, the loss of portions or all of several panels did not lead progressively to the destruction of the rest of the wall. In addition, the subdivision of each structural bay with a tight network of vertical, horizontal, and diagonal timbers, rather than vertical studs alone, appeared to have been successful in reducing the possibility of the masonry falling out of the frames. Fig. 14 shows masonry infill damages for traditional *hımış* constructions. It should be noted that there is no a problem such as dislodgement of the infill for traditional *dizeme* and *bağdadi* constructions.

Fig. 14. Masonry falling out of the frames for traditional himiş constructions. (a) Damaged during 1999 Kocaeli earthquake [7]. (b) Damaged during 2000 Çankırı earthquake [19].

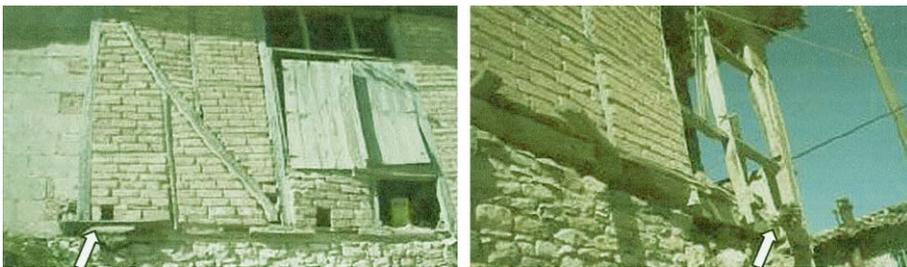
that these buildings may slide off their foundation during earthquakes. Fig. 15 shows two himiş constructions whose vertical framing elements were slide off their foundation during the 2003 Buldan earthquake. If reinforced concrete foundation and anchor bold are used, it is prevented structures from moving off its foundation.

Fig. 15. Slide off frame elements from supporting systems during the 2003 Buldan earthquake [15].

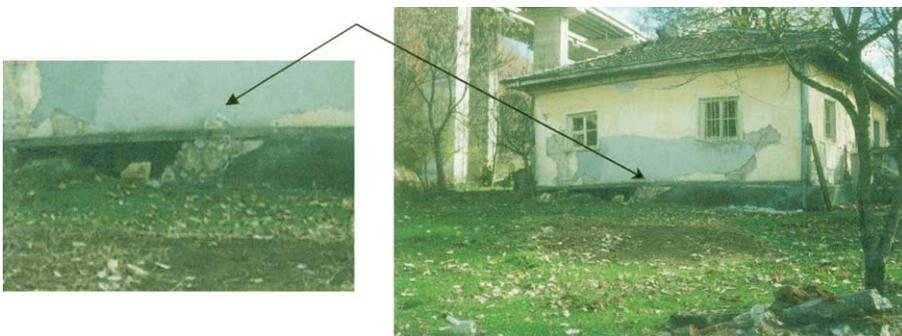
Fig. 16 shows failure of stone masonry foundation wall during the 1999 Düzce earthquake. But it should not be accused too much since fault rupture crossed just under the building as shown in the figure. Yet, it succeeded to survive during the earthquake with only repairable foundation failure.

Fig. 16. Failure of masonry foundation of a himiş construction just over the fault rupture during the 1999 Kocaeli earthquake.

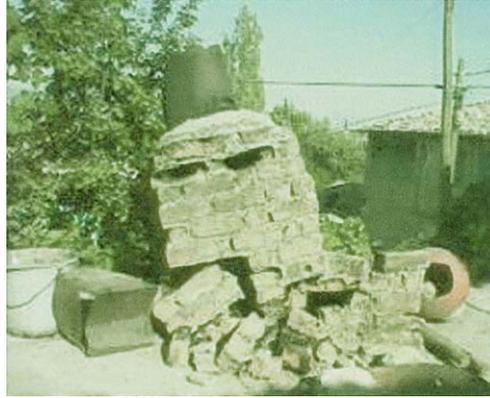
Fig. 17. A collapsed chimney of traditional building during the 2003 Buldan earthquake [15].

Failure of the chimneys can generally cause damage to the roof and walls of the building below. But especially in some kinds of Turkish traditional buildings the failure of chimney may cause fire. Fig. 17 shows failure of a chimney during the 2003 Buldan earthquake. Unreinforced masonry chimneys are particularly susceptible to earthquake damage. Also damaged chimneys may be dangerous in aftershocks following the initial earthquake. Bracing chimneys or using chimneys from lighter materials can help prevent damage [32].
